The Electronic Anti-Scale System For Cooling Tower Applications

Vulcan — The chemical-free solution

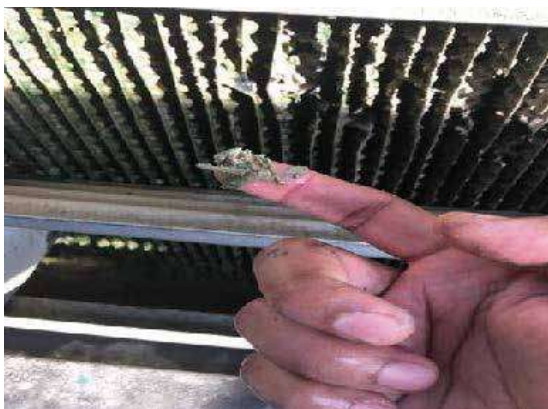
With Vulcan, scale becomes loose.

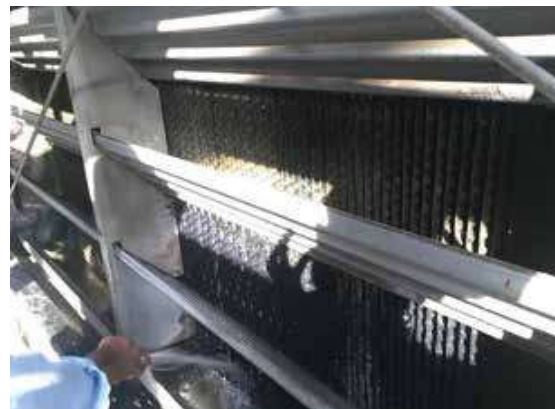
Scale and algae can be removed easily by a water gun.

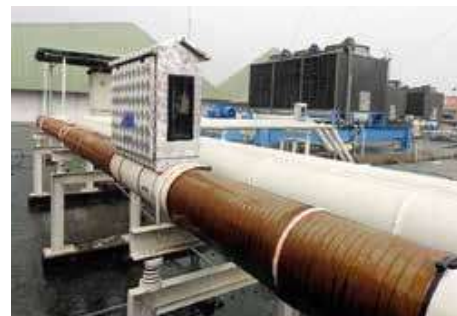
Vulcan S500 was located inside aluminum box and installed on a cooling tower main pipe.

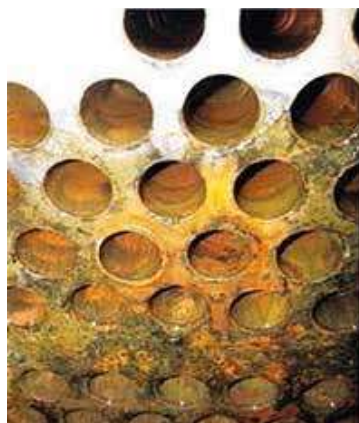
First Inspection: March 4, 2014.

The heat exchanger tube plates were removed to reveal the inside surface of the copper tubes. Since these tubes had recently been manually cleaned, virtually no scale was present, as is on this photo.

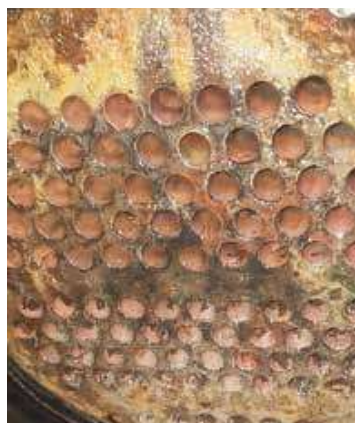
Last inspection: February 12, 2018 at the end of the 4-year trial

The inside surfaces of the copper tubes show zero additional scale formation after 4 years in the test period.

The photographs show that the refrigeration condenser tubes, from the beginning to the end of the trial period, were "as clean as new".

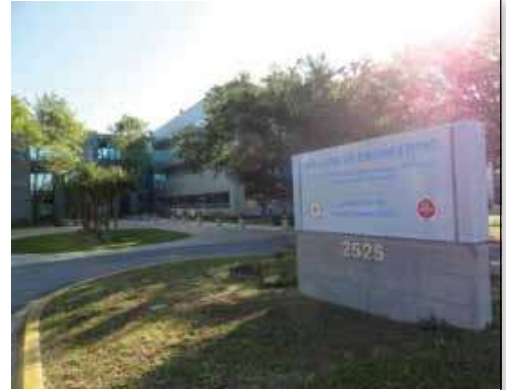
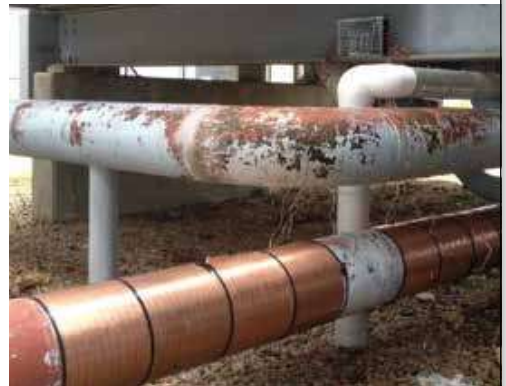
Vulcan S250 installed on a 10 inch diameter line that feeds twin cooling towers (CT-1 and CT-2)

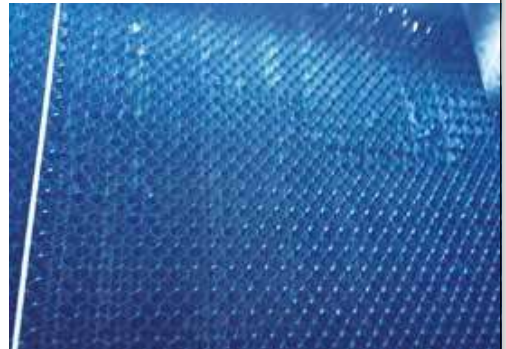
The inside of CT-1, after **3 weeks** with Vulcan. It illustrates clean flutes that are in constant contact with Vulcan-treated water and a few dry (untreated) areas that still have some remaining green biofilm.

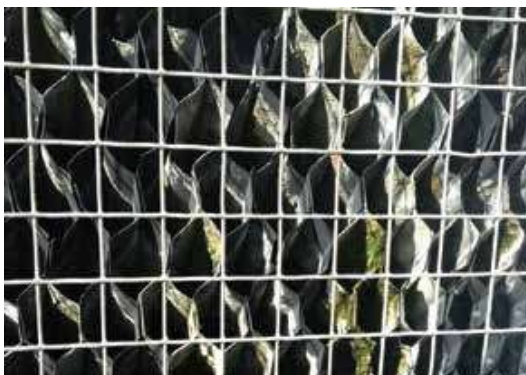
The photo above was taken of CT-1 about **3 weeks** after the Vulcan was installed.

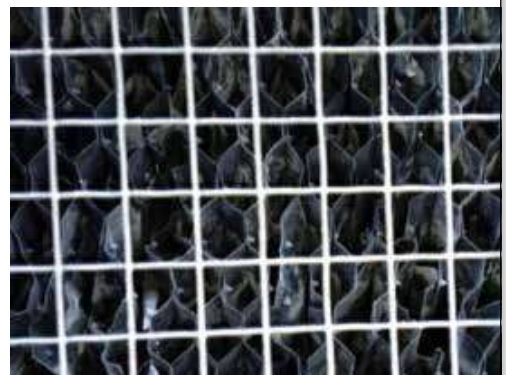
The photo above was taken of CT-1 about **6 weeks** after the Vulcan was installed.

After 1 month, the green biofilm had almost completely disappeared from the surfaces in contact with the Vulcan-treated water. The flakes of scale previously observed had fallen off in most places. The cooling tower flute surface area covered with scale deposits had been decreased by **over 60%**.

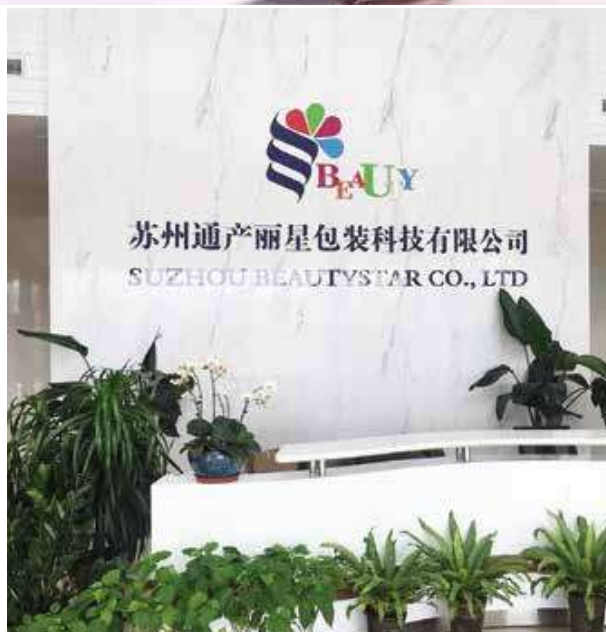
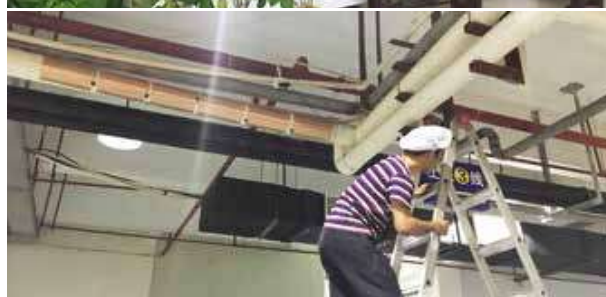
Before Vulcan was installed in front of the filter, it was badly scaled.

After Vulcan was installed, the scale on the inner wall has been removed and the coating has gradually appeared.

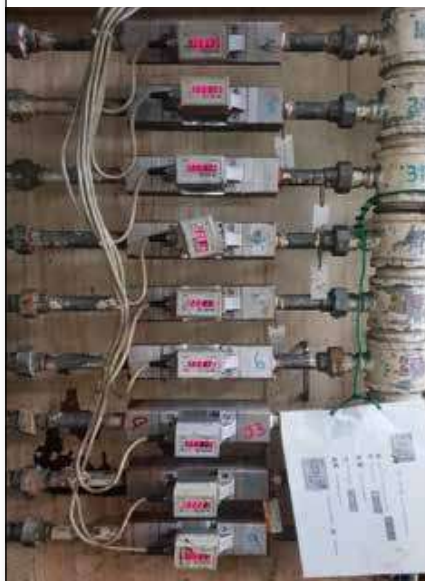
There are 9 secondary small pipes with water meters. These meters were installed to make sure a stable flow rate. If the flow rate goes down, it would cause a problem of the induction hardening machine. Therefore, the pipes had to be cleaned manually every 2-3 months.

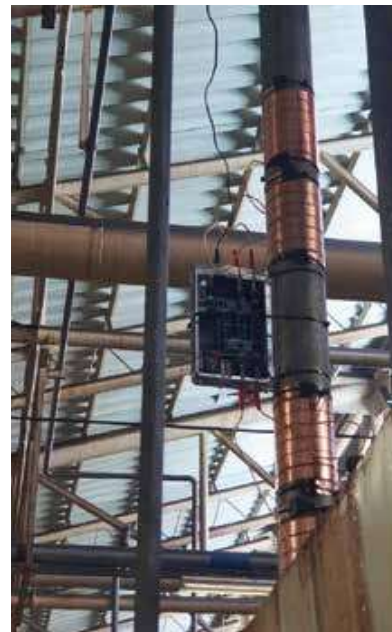
Vulcan S25 was installed around 50 meter before the induction hardening machine.

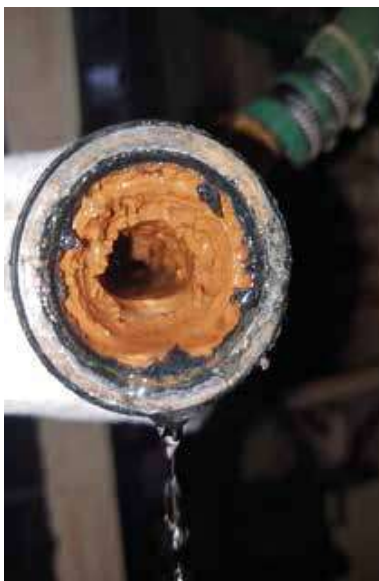
First inspection:
May 21, 2018.

Inside of a secondary small pipe, before Vulcan S25 was installed.

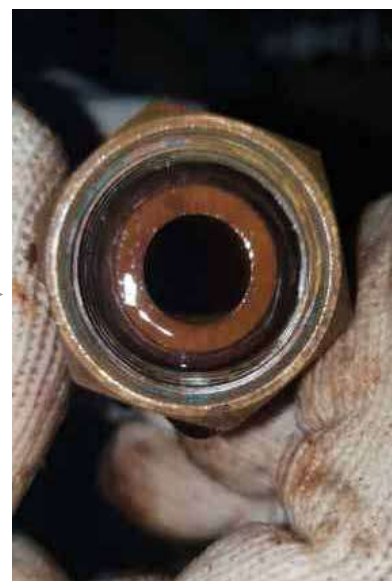
Last inspection:
November 21, 2018.

After 6 months with Vulcan treatment: the pipe is free of scale.

2. After Vulcan S25 had been installed for 6 months, the secondary pipes were opened: scale that had been left in piping had disappeared and all 9 secondary pipes had become clean (see photo).

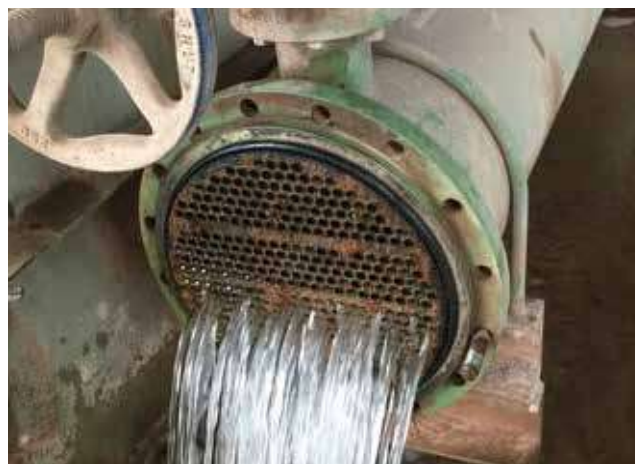
Heat exchanger after 2 months Vulcan installation

- oil heat exchanger is clean
- temperature is stable at 37°C – 40°C
- no need to stop machines to clean anymore
- save 7% energy consumption at grinders

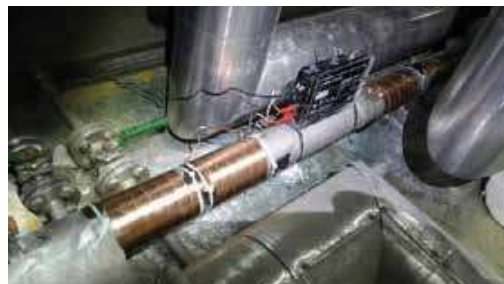
Vulcan S25 installed at Toray Industries

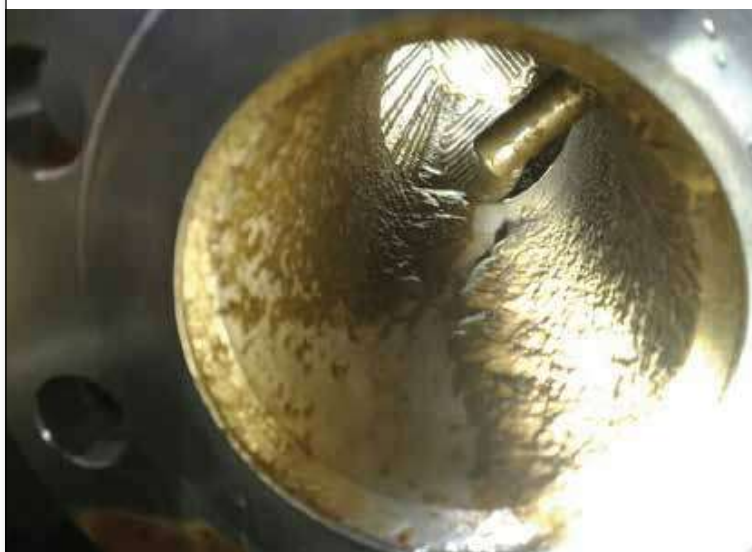
Before – without Vulcan

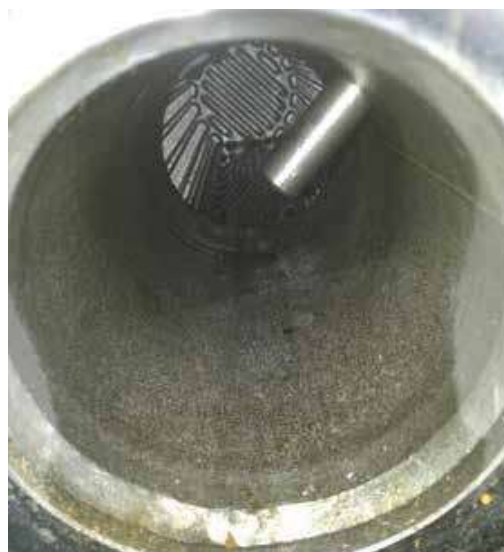
After 3 months – with Vulcan treatment.
Up to now the installed pipeline needed no cleaning.

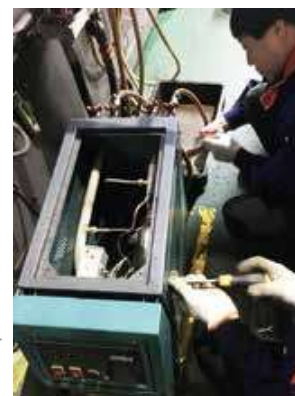
One and a half years after Vulcan was installed, we opened the mold temperature controller and checked the heat exchanger.

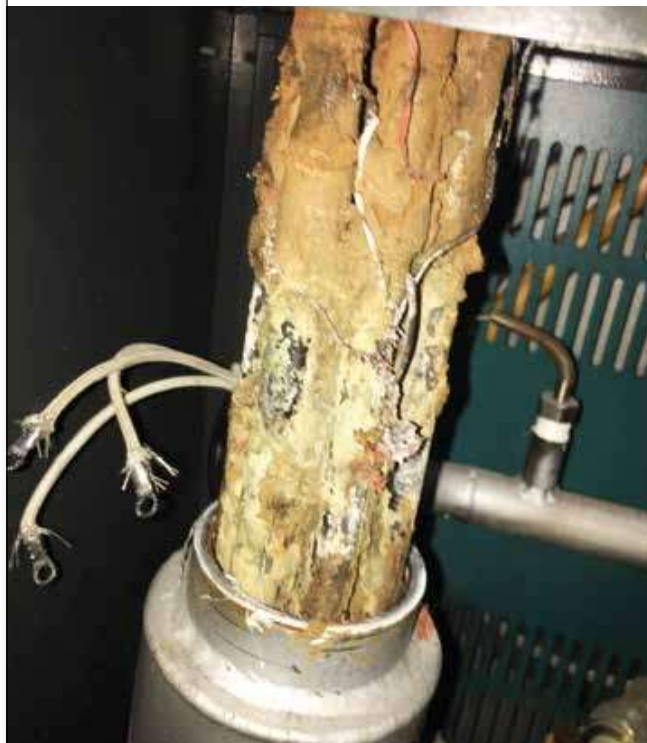
Untreated heat exchanger for 3 years.

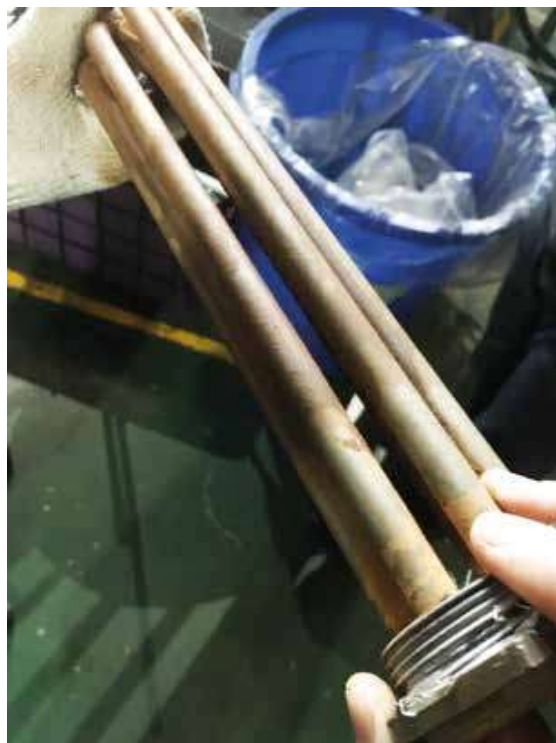
After installing Vulcan for 1.5 years, the scale is gone without extra cleaning.

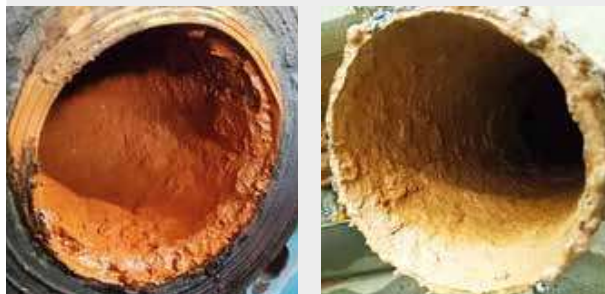
The pipe had been used for 15 years and had a very thick hard scale layer inside. The pipe was not cleaned before Vulcan S10 was installed. The following two photos are the observation points selected before Vulcan installation.

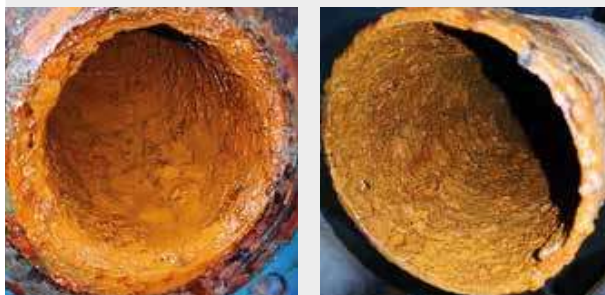
After Vulcan S10 was installed for 4 months

The scales inside the pipe have been gradually reduced, and they do not fall off in blocks, which will not affect the operation of pumps and other equipment. Because of the good results, the customer decides to apply Vulcan in several other cooling systems.

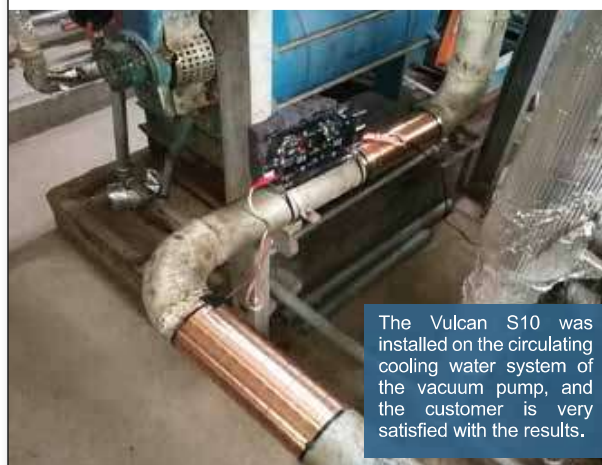
The Vulcan S10 was installed on the circulating cooling water system of the vacuum pump, and the customer is very satisfied with the results.

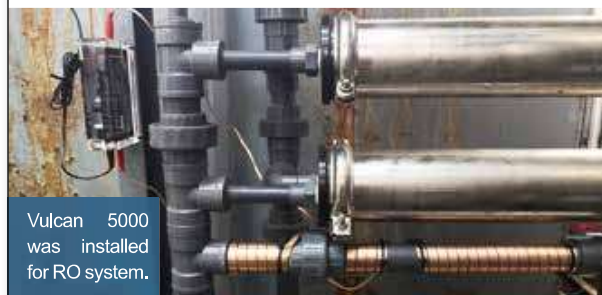
Vulcan 5000 was installed for RO system.

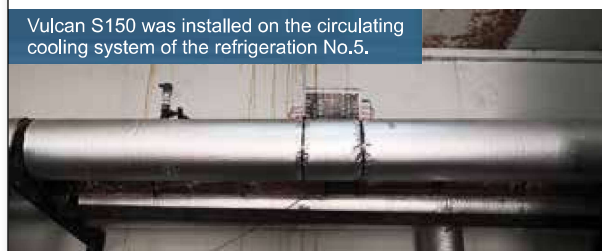
Vulcan S150 was installed on the circulating cooling system of the refrigerator No.5.

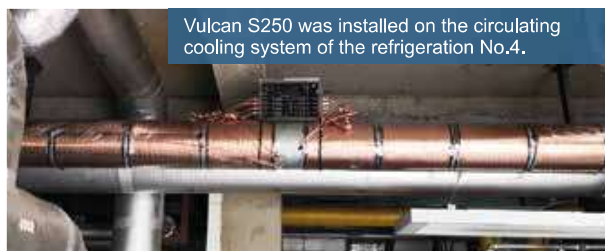
Vulcan S250 was installed on the circulating cooling system of the refrigerator No.4.

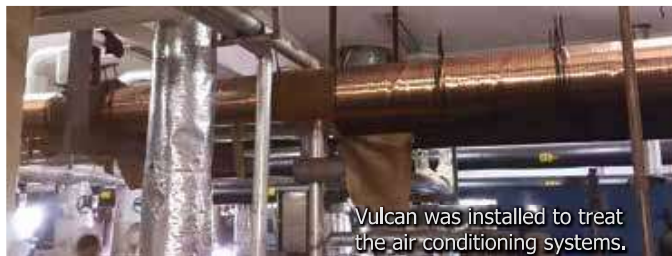
Vulcan effect in the factory — before and after

Cooling tower fins: the silica (SiO_2) which was usually accumulated in the fins has disappeared; the energy consumption of the air conditioning systems and the cleaning effort have been reduced.

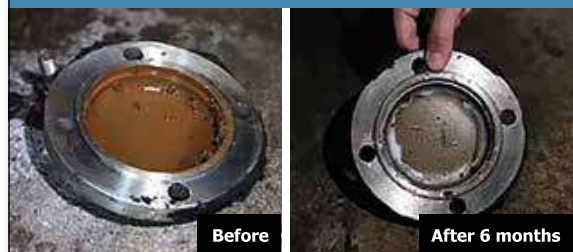
Cooling tower valve: large amount of sludge and scale have been gradually reduced.

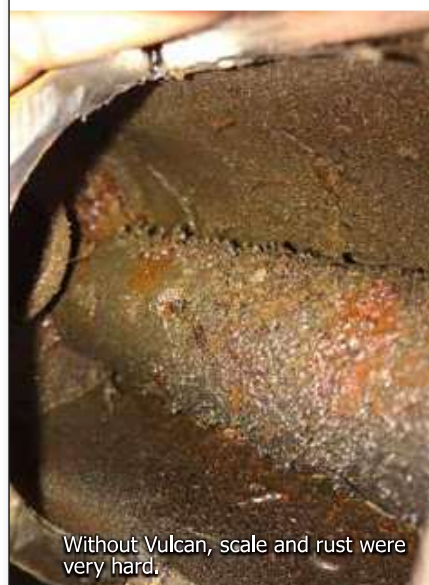
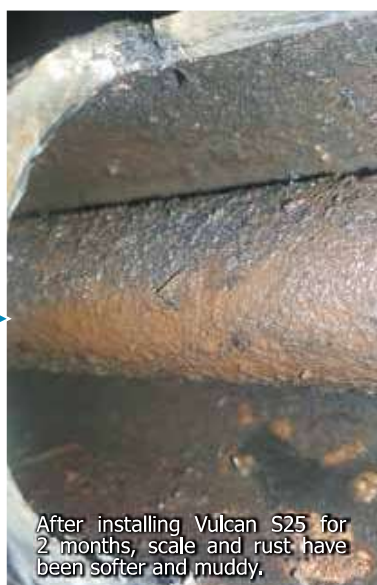
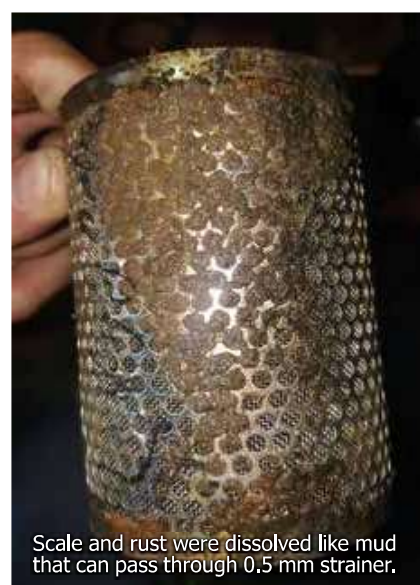
Vulcan S25 were installed as a test for a small stirrer for 3 months, and the scales in the paddle have been greatly reduced. Thus, the client purchased 2 x Vulcan S500 to treat the cooling water systems.

Many scales were in the piping systems, glass stirrers and the cooling towers. The client had to change the stirrers every year.
