# The Electronic Anti-Scale System For Hospitality Applications

## Vulcan — The alternative to water softeners

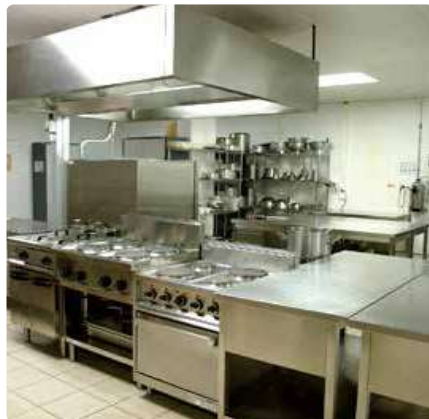
a) Without treatment

b) With Vulcan treatment

Pictures a/b show the results in a grease trap before and after treatment. As Vulcan works without chemicals or salt, the natural taste of water is preserved. Vulcan reduces the amount of scale deposits. It offers you a permanent solution without ongoing costs, repairs or replacements.

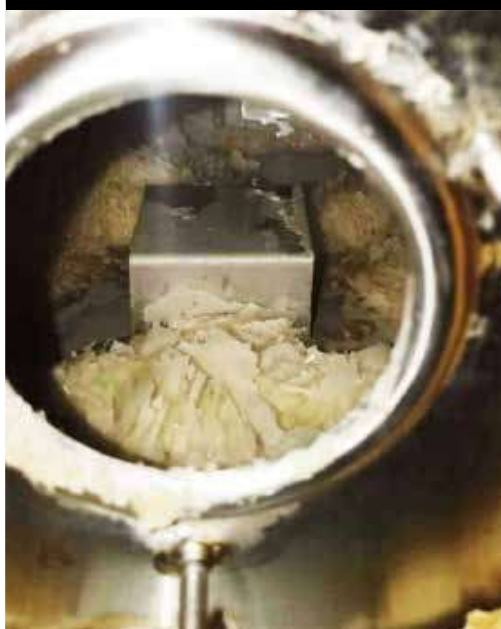
The untreated steamer

The scale was in flakes and could not be drained out of the steamer's drain hole. To test the effectiveness of the Vulcan system, no cleaning process was carried out before installing the Vulcan S10.

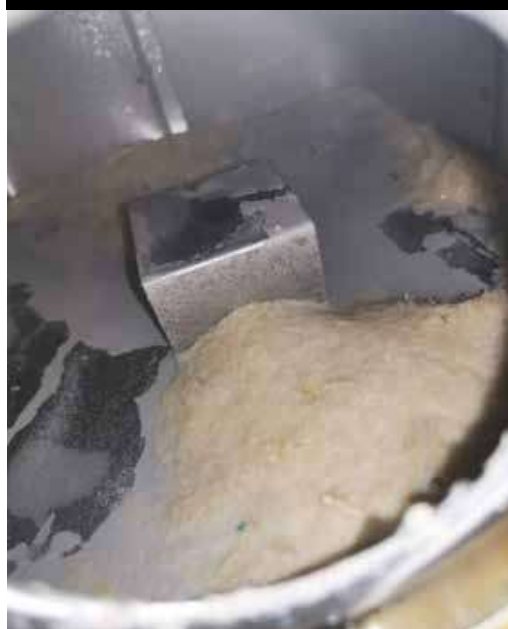
The steamer after using Vulcan S10 for 2 months

The scale has been completely turned into powder, so there is no need to open it for cleaning, just by operating the regular drainage function, it can keep the hot water tank clean and free of scale. Due to the good results, the cooperation will also be carried out in the hotel's hot water supply system and central air conditioning system.

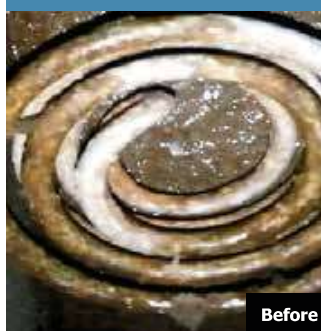
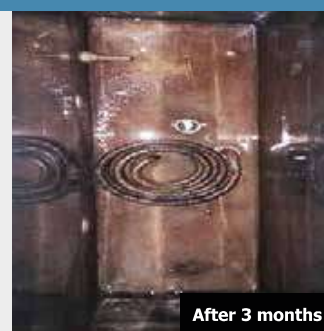
#### Hot Water Tank

After 3 months scale is no longer forming and the hot water tank is free of scale and sediment.

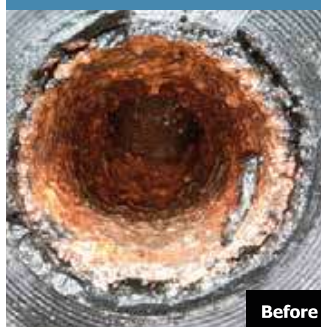
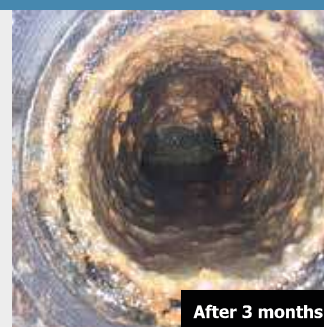
#### Hot Water Pipe

After 3 months the rust in the pipe has lightened and the amount of scale is gradually reducing.

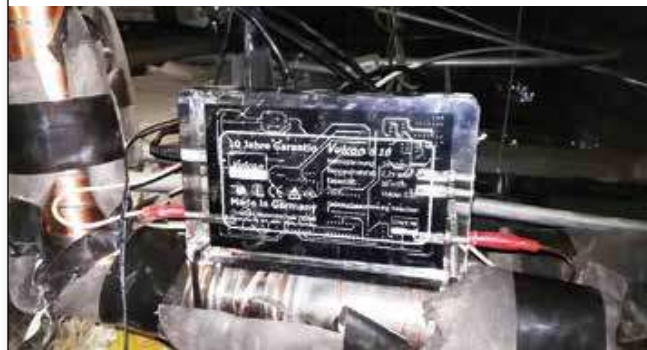
Vulcan S10 was installed on the main water line of the Chinese kitchen.

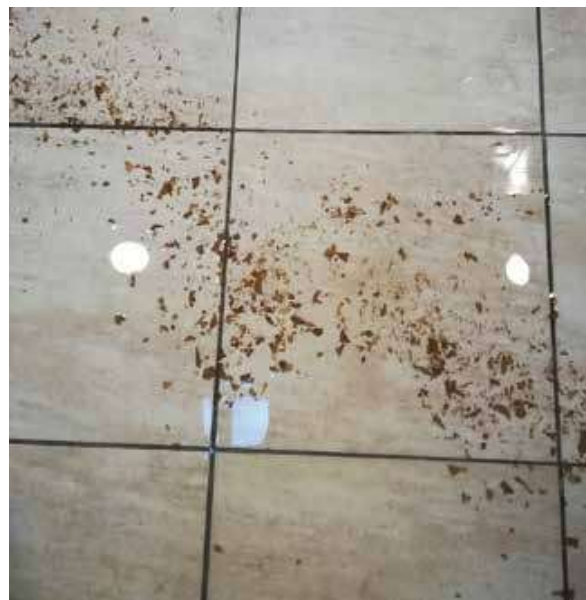
The scale scrap came out of the steamer in the Chinese kitchen.

One month after the Vulcan S10 was installed, we opened the sewage outlet of the Chinese kitchen, and found that the scale scrap came out. At the same time, we compared the sewage outlet of the western kitchen without Vulcan, there is no scale coming out. The hotel manager is very satisfied with the results and is making a new purchase.

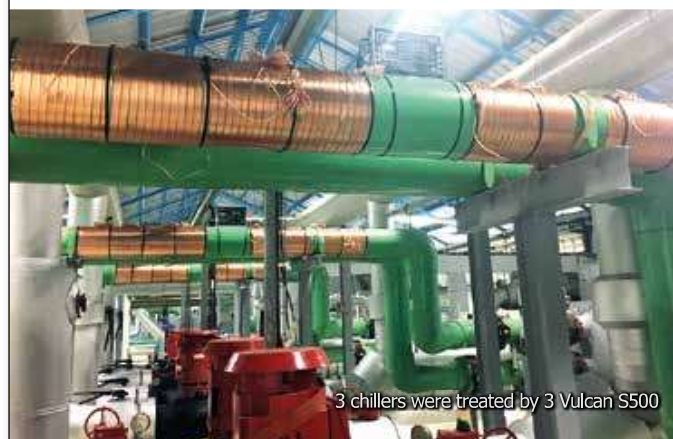
3 chillers were treated by 3 Vulcan S500

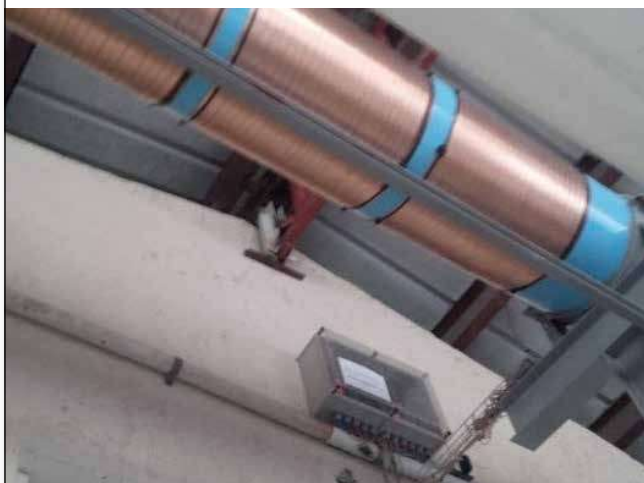
Vulcan S500 protective casing

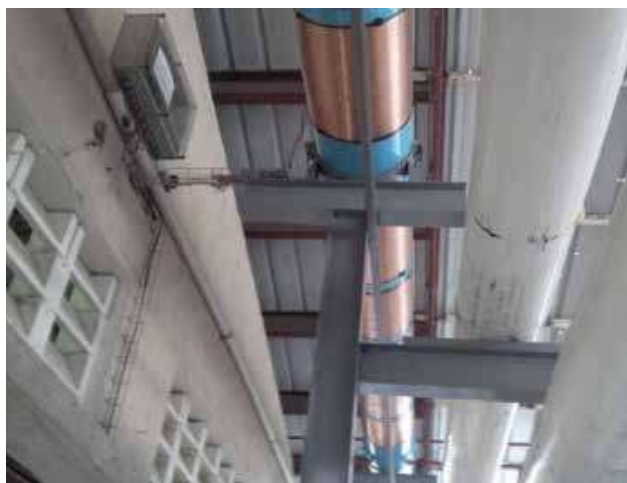
Vulcan S500 cable windings

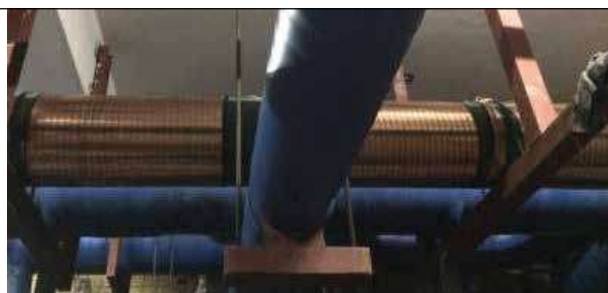
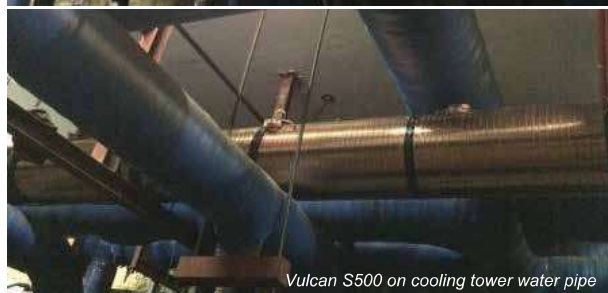
Vulcan S500 on cooling tower water pipe

Chiller #3 Condenser  
Ø 67 cm, tube Ø 7/8", length: 418 cm

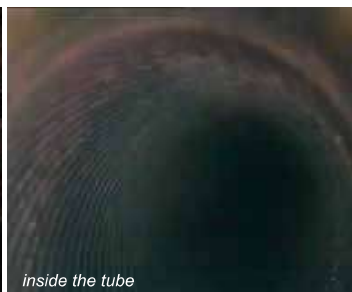
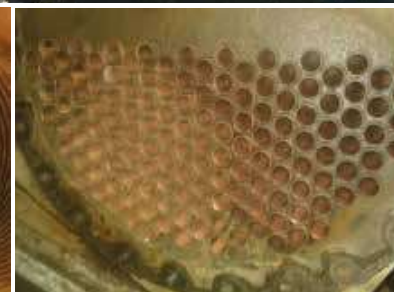
inside the tube

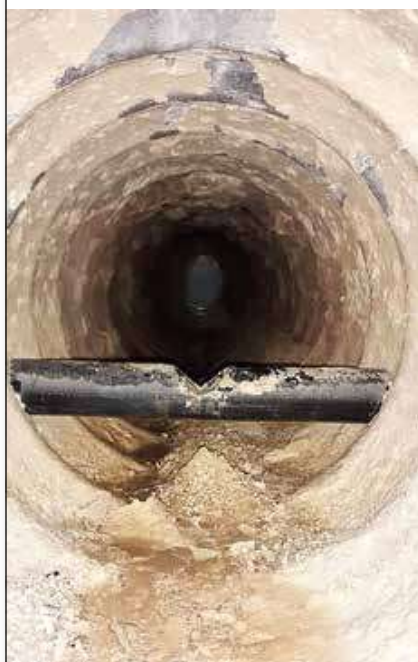
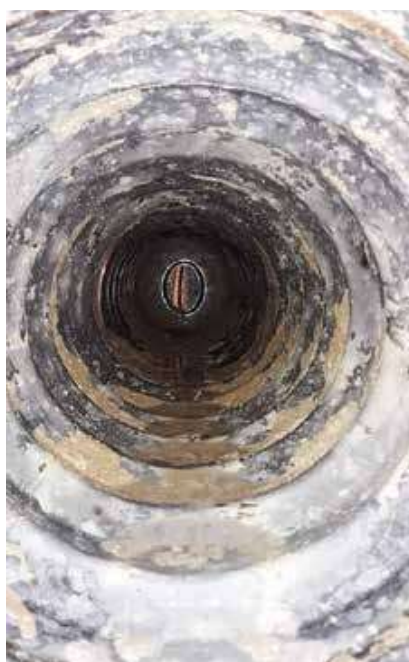
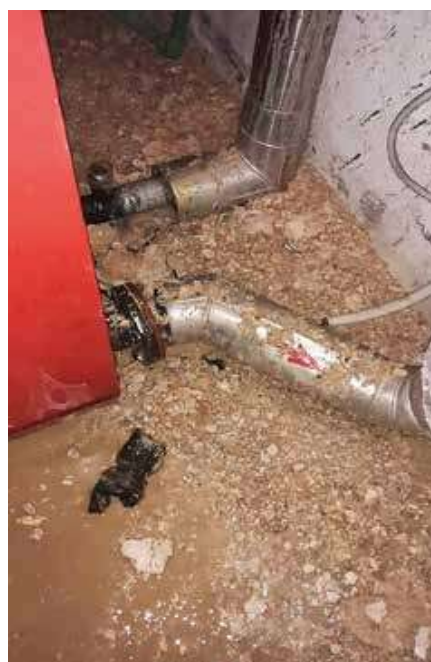
After Vulcan S25 had been installed for **6 months**, the boiler was opened: scale had been softer and left out.

The scale deposits were easily removed with a water gun.

The scale deposits were drained out of the boiler with ZERO chemical.

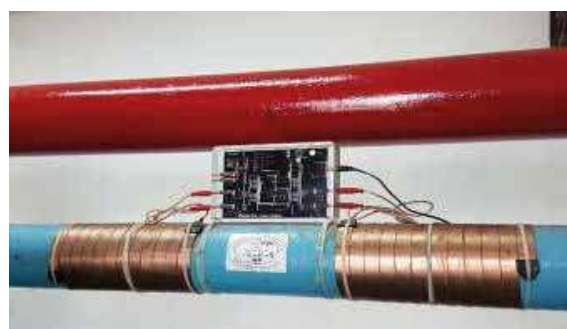
**Anti-Scale System Vulcan S25 installed**

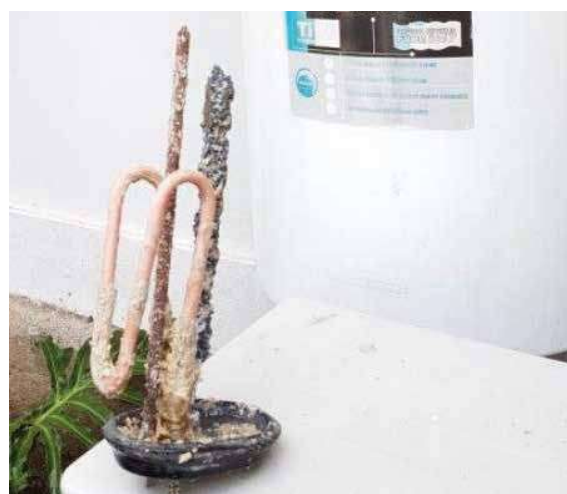
*The little remaining scale is soft and easily flushed out since installation of the Vulcan Anti-Scale System.*

One of the water heaters at a Sea View Bungalow (photo) was opened for inspection and showed much dislodged scale particles at the bottom of the tank, with some easily removed soft scale still present on the element only. This water heater unit had not been scheduled for random inspection since installation of the Vulcan unit at the Resort.

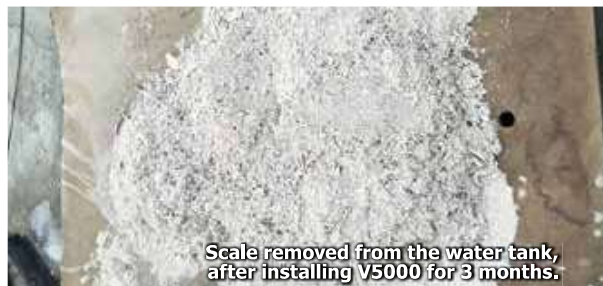
Scale removed from the water tank, after installing V5000 for 3 months.

3. After 3 months of installation, we cleaned the hot water tank, and found a large amount of scales were drained out. The photo below is the scales removed from the water tank. Also, the heat transfer efficiency of the solar system has been significantly improved, the performance almost has stayed the same just like the beginning of installing Vulcan.

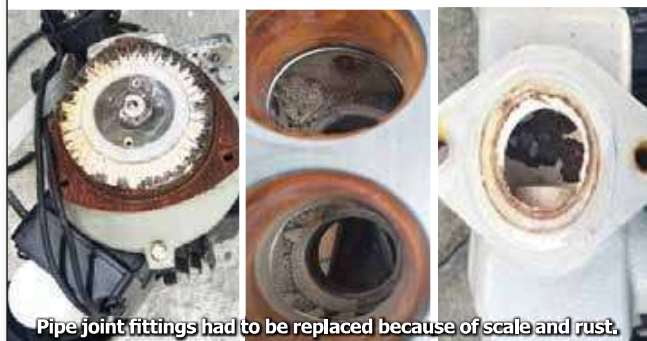
Pipe joint fittings had to be replaced because of scale and rust.

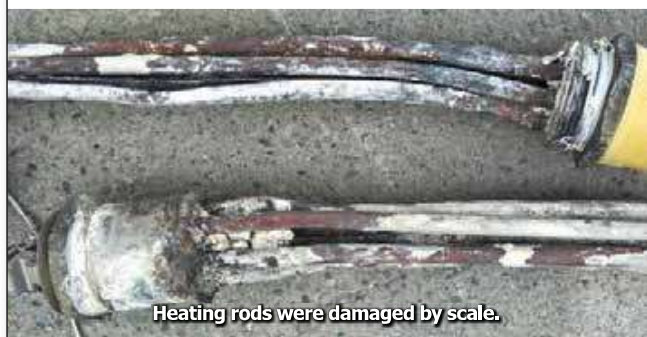
Heating rods were damaged by scale.

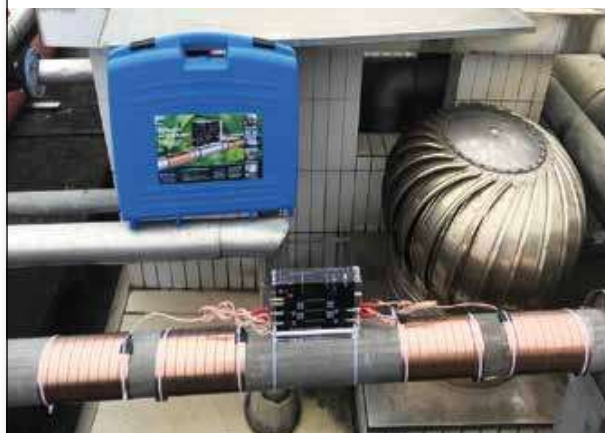
Vulcan S25 was installed on the main water pipe of the guest room Building B.

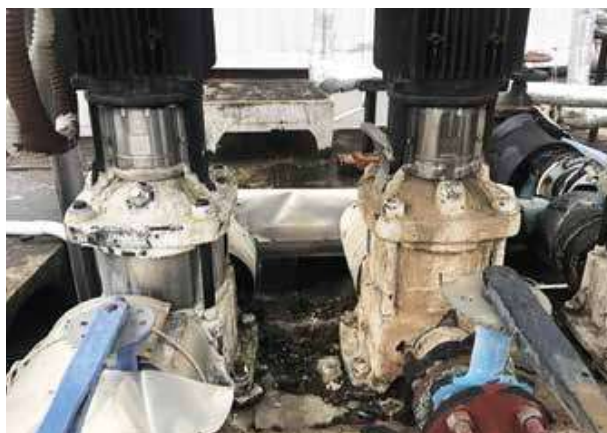
On the left is the pipe (without scale) after Vulcan S25 was installed for 2 months; on the right is the pipe without any water treatment.

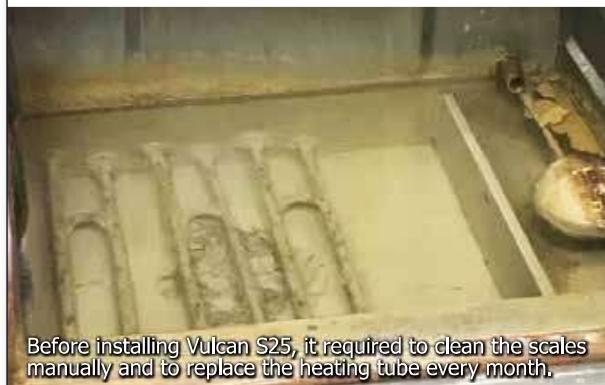
Before installing Vulcan S25, it required to clean the scales manually and to replace the heating tube every month.

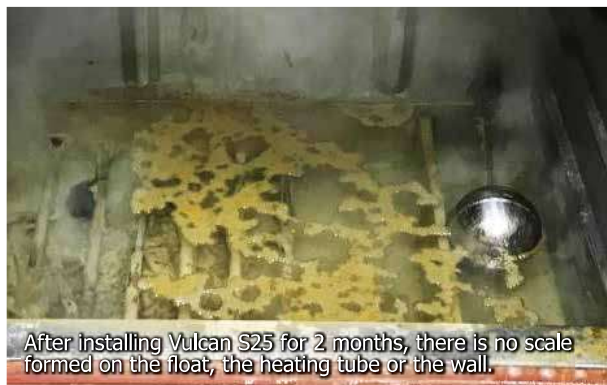
After installing Vulcan S25 for 2 months, there is no scale formed on the float, the heating tube or the wall.

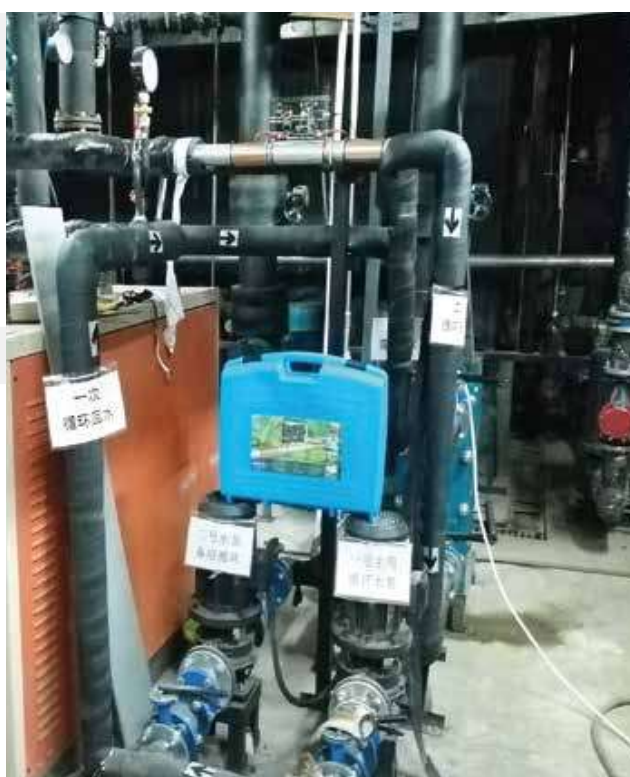
Vulcan S10 was installed in the hot water system of the hotel
