# The Electronic Anti-Scale System For Restaurants and Kitchens

## Vulcan — The alternative to water softeners

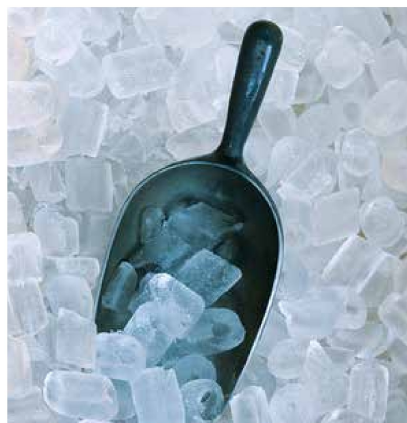
Ice machines operate more efficiently and ice cube formation is enhanced.

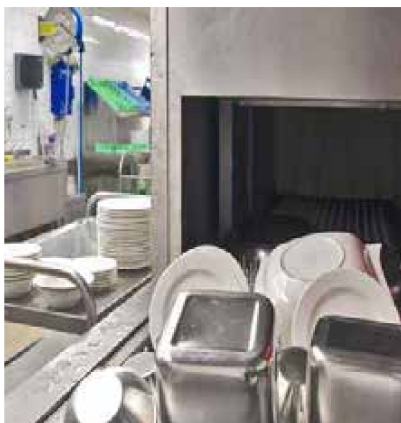
Dishwasher scale is reduced significantly and dishware is now spot-free.

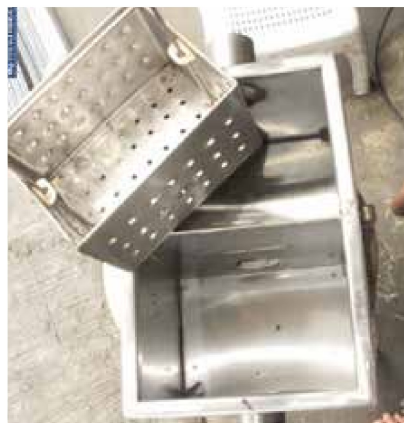
Grease traps have reduced odors and more consistent, less cluttering grease.

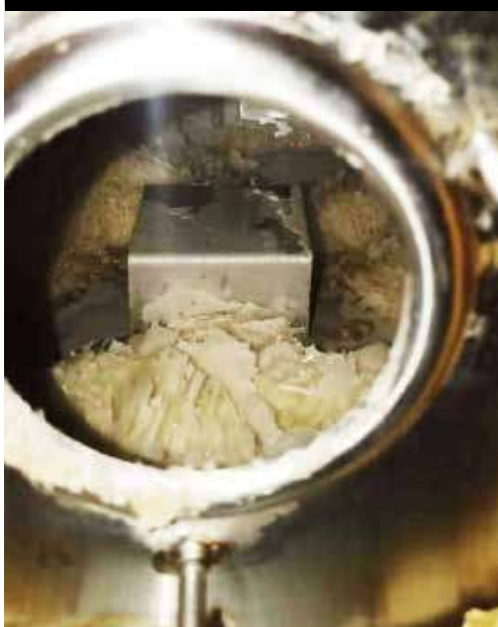
The steamer after using Vulcan S10 for 2 months

The scale has been completely turned into powder, so there is no need to open it for cleaning, just by operating the regular drainage function, it can keep the hot water tank clean and free of scale. Due to the good results, the cooperation will also be carried out in the hotel's hot water supply system and central air conditioning system.

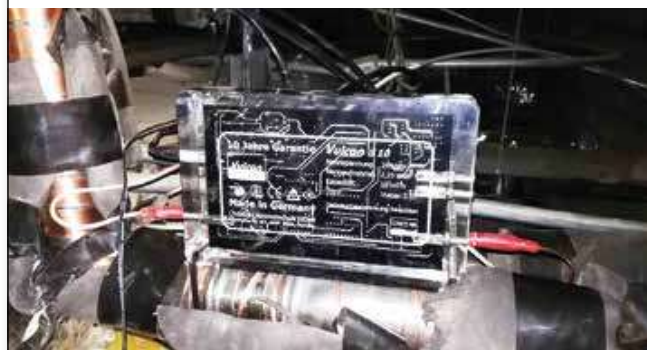
Vulcan S10 was installed on the main water line of the Chinese kitchen.

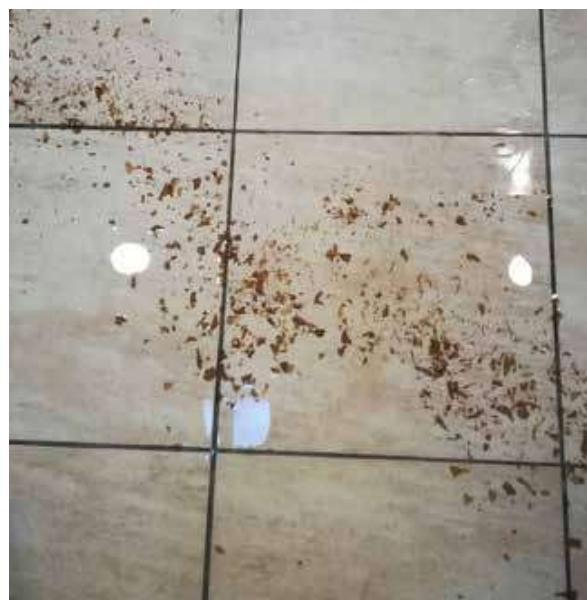
The scale scrap came out of the steamer in the Chinese kitchen.

One month after the Vulcan S10 was installed, we opened the sewage outlet of the Chinese kitchen, and found that the scale scrap came out. At the same time, we compared the sewage outlet of the western kitchen without Vulcan, there is no scale coming out. The hotel manager is very satisfied with the results and is making a new purchase.

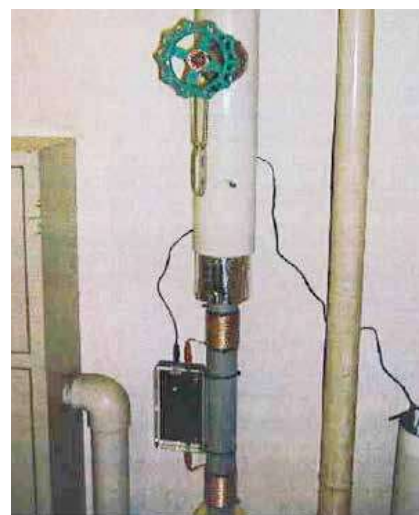
Vulcan 5000 was installed in the factory kitchen

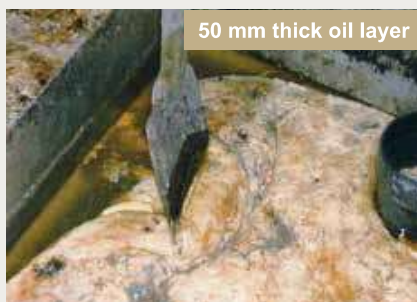
50 mm thick oil layer

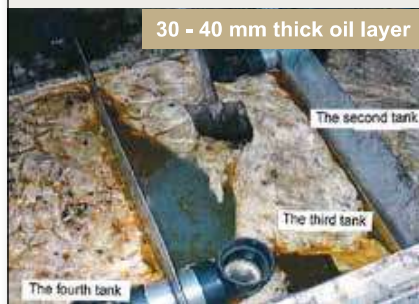
30 - 40 mm thick oil layer

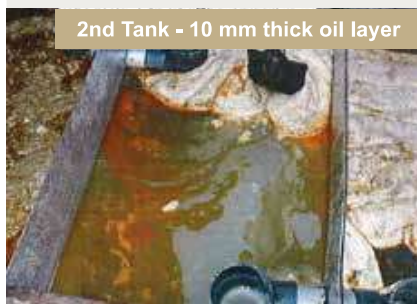
2nd Tank - 10 mm thick oil layer

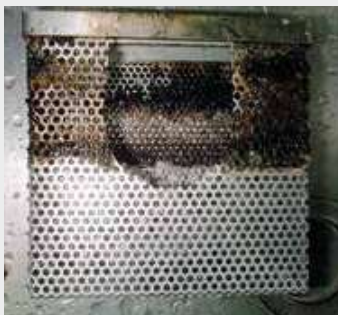
The basket after being washed by hosing. The portions usually being contacted with the treated water are cleaned easily with a water flow from the tap.

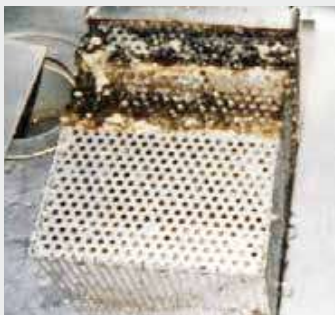
The status after being used without cleaning since the installation in June (no adhered materials are seen on the portions usually contacting with water).

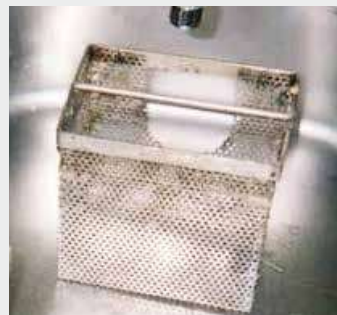
Grease trap was cleaned with water flow under the sink.

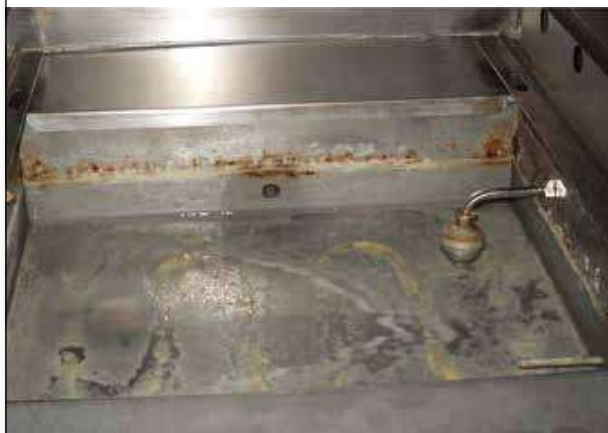
Pan before Vulcan installation, hard calcium and etched line present.

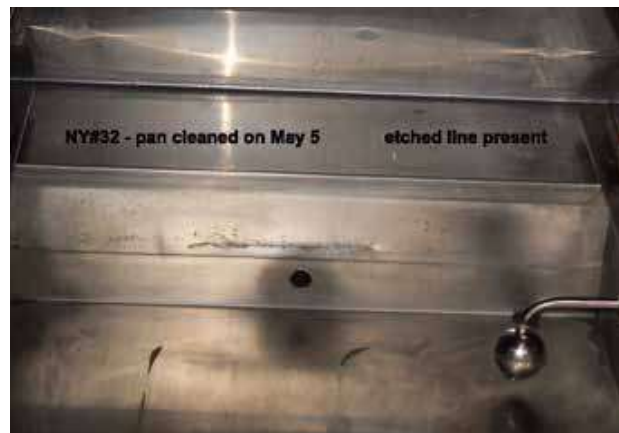
After Vulcan installation — pan area is now completely scale-free. There is a slight indentation into the pan at the waterline.

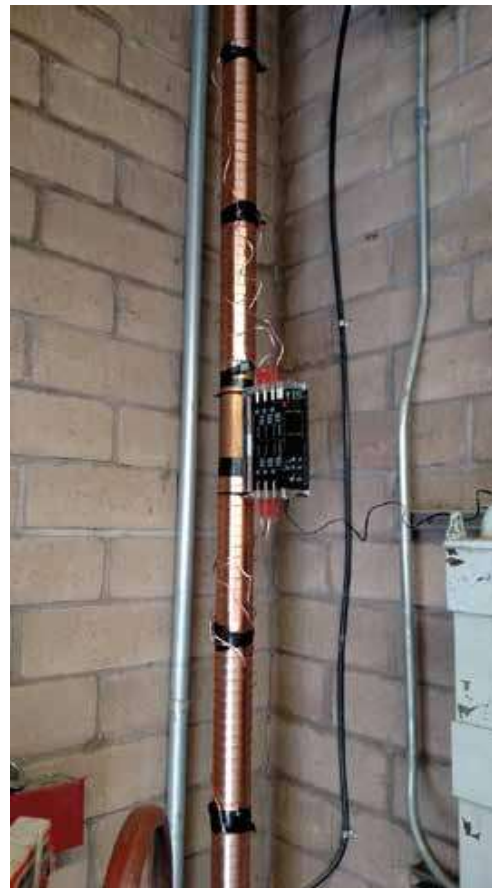
Vulcan S100 installed on the main water line

It also wreaks havoc with the boilers and water heaters. After Andy and Vulcan Water Products installed the S100 unit on the main line, we noticed real soon, that the showers were becoming cleaner, and the discoloration in the water was gone too!

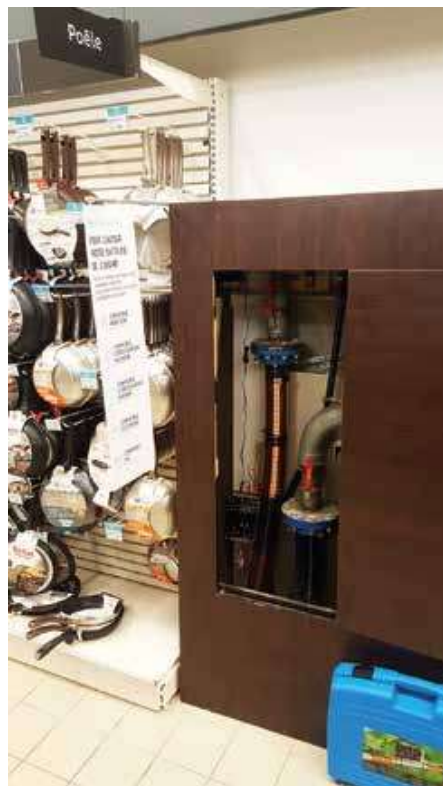
Vulcan S25 was installed in the water main to treat the whole building.
